Manhole Inspection Summary

Manhole # S35II_017MH

Insp Date: **3/13/07 8:25 AM**

Location Address: **1600 CALVERT ST**

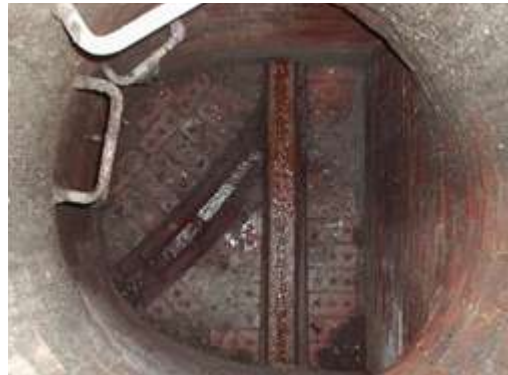
Infiltration: ☐ None ☐ Joint ☐ Cracks ☐ Mortar ☐ Roots ☒ **Wall**

Bench ☒ Exists Material: **Brick** ☐ Parged ☒ **Debris** (not Condition related)

Surcharge ☒ **Evidence Of Surcharge** Depth: **4** (ft.) ☐ Active Surcharge Present

Barrel infiltration. Evidence of surcharge - Bench debris.

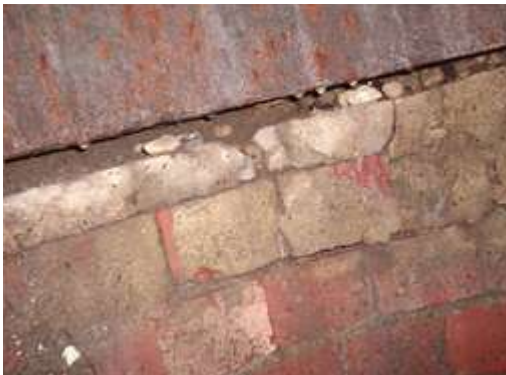
Defect

Frame Offset: **1** (in.) Condition: ☐ Sound ☐ Cracked ☒ **Leaks**

Condition: ☐ Sound ☐ Cracked ☐ Root Intrusion ☐ Loose Brick ☒ **Deteriorated**

Infiltration: ☐ None ☒ **Joint** ☐ Cracks ☒ **Mortar** ☐ Roots ☐ Wall

Frame leaks. Adjustment deterioration and infiltration.

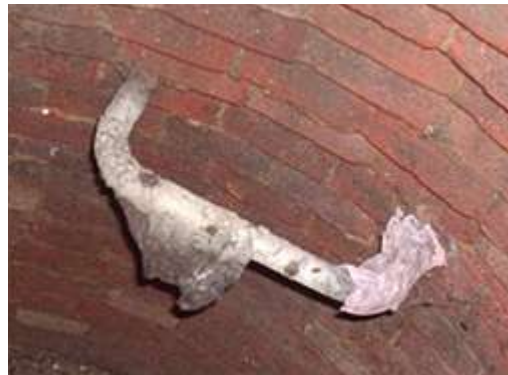
Defect

Evidence of surcharge.

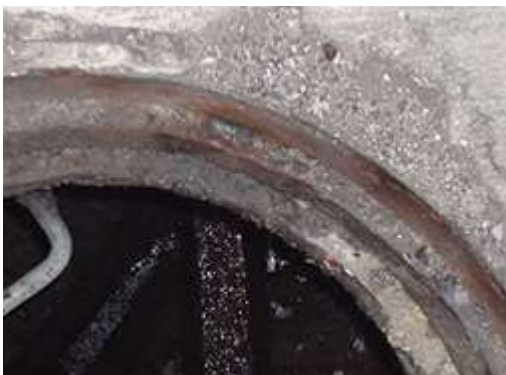
Defect

Frame offset.

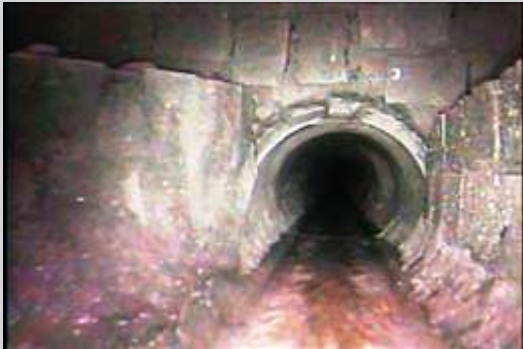
8 in. Circular Gravity Sewer Pipe Out @ 12 O'Clock

Channel deterioration.

Deposits: ☐ None ☐ Mud ☐ Sludge ☐ Debris ☒ Grease

Silt Depth: **0** (in.) Deposits Extent: **Light**

Infiltration: **Evidence** Pipe Seal Cond: **Broken**

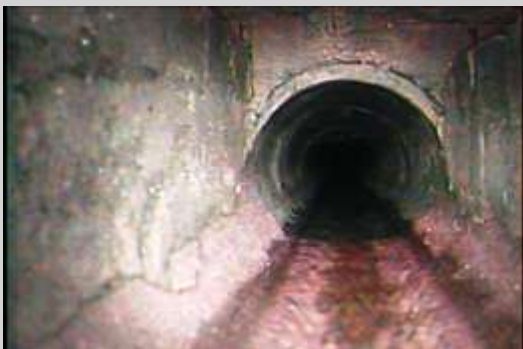
8 in. Circular Gravity Sewer Pipe In @ 6 O'Clock

Invert Depth: **8.22** (ft.) Flow Characteristics: **Slow**

Deposits: ☒ None ☐ Mud ☐ Sludge ☐ Debris ☐ Grease

Infiltration: **None** Pipe Seal Cond: **Unknown**

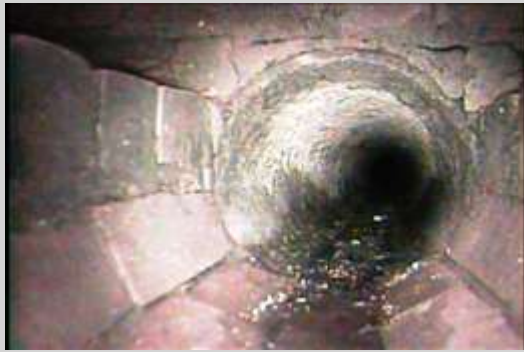
8 in. Circular Gravity Sewer

Deposits: ☐ None ☐ Mud ☐ Sludge ☒ **Debris** ☒ **Grease**

Deposits Extent: **Light**
